EASTFIELD PARK NORTHAMPTON

STATE OF THE PARK

(Footpaths, Facilities & Ground Conditions)

January, 2018

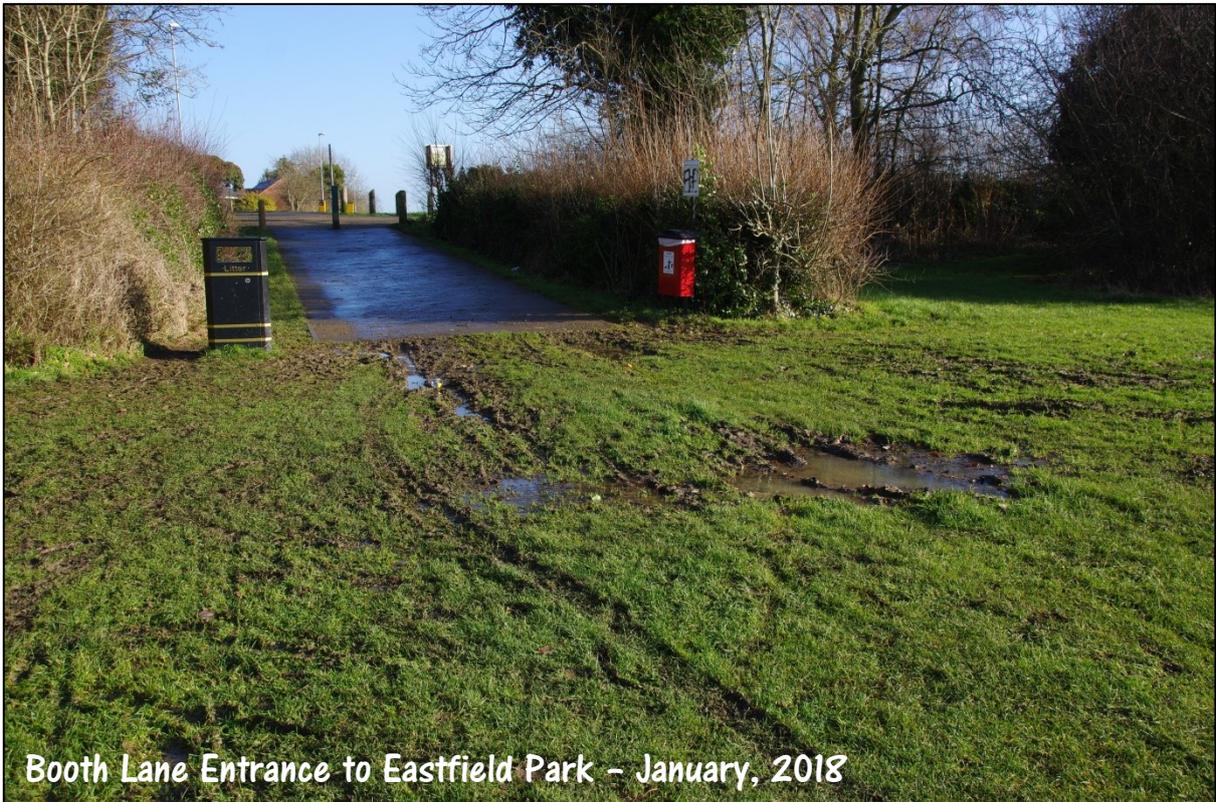
Booth Lane Entrance to Eastfield Park – January, 2018

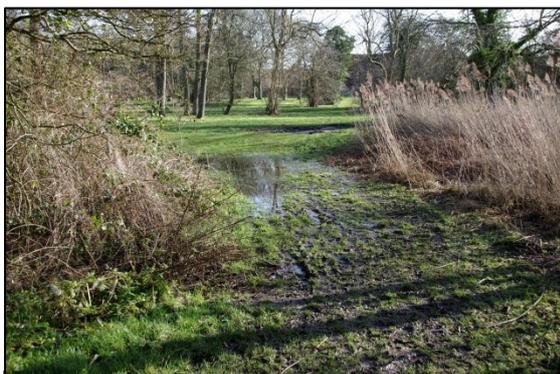
Fig. 1: Standing water and muddy ground across the path to the north-east of the Lake.

Additional survey work is required before the fourth pathway can be costed but this would pass around the Lake and would consist largely of a board walk crossing some of the wettest areas of the Park (including the areas shown in Figs. 1 and 5).

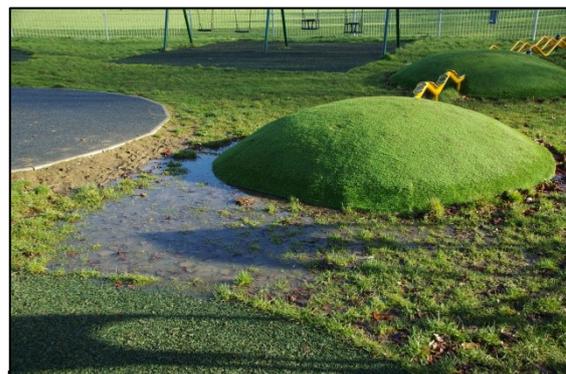
Fig. 2: Large puddle in the new Junior Play Area.

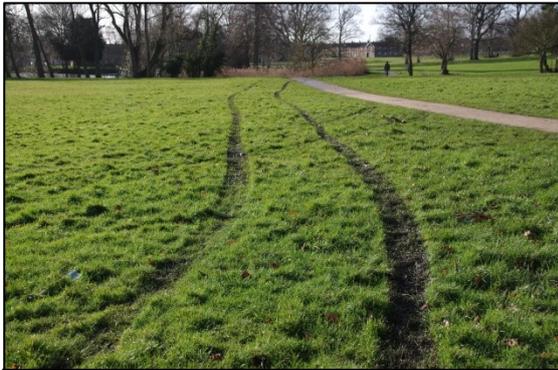
Fig. 3: Tracks across Skiddaw Walk field caused by an official vehicle.

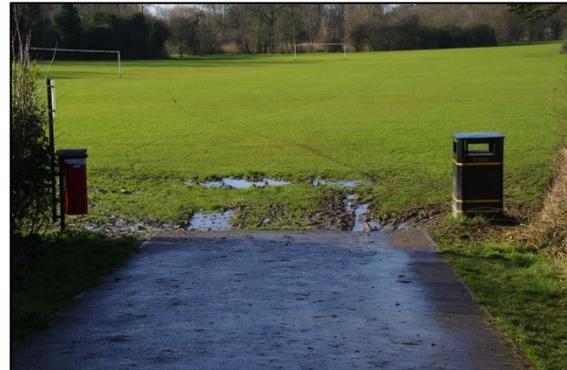
Fig. 4: Surface damage between the Booth Lane entrance and the football pitches.

Deterioration of footpaths and equipment due to normal wear and tear has been minimal but both authorised and illegal vehicles have damaged footpaths and the the surface of the Park. In particular, vehicles have continued to damage Mallard Walk where it passes by the Lake and motorcycles have caused potholes in the southern part of the Walk. Damage to the ground just inside the Booth Lane entrance is also significant (Fig 4 & title page).

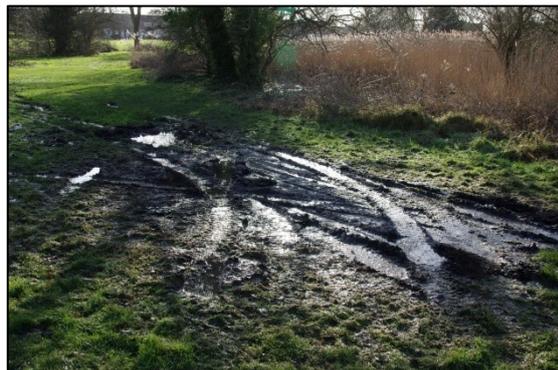
Fig. 5: Damage to the Park's surface caused by a vehicle that was burnt on the Park.

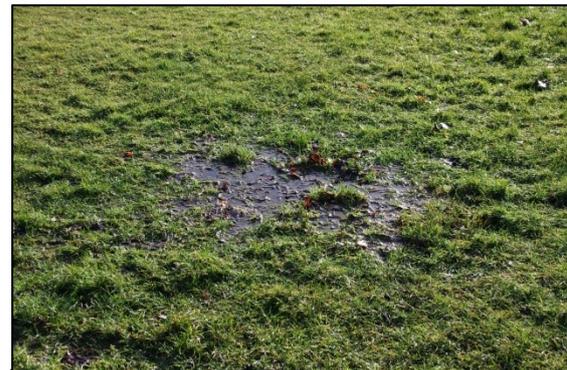
Fig. 6: Waterlogged ground in the Skiddaw Grassland area of the Park.

The situation on the open grassy areas of the Park is very variable and it can be difficult to find a route across the Park without sinking into wet ground (Fig. 6). It is because of the sodden nature of much of the ground, particularly (but not exclusively) in winter, that some residents have called for better drainage of the Park. Some years ago, NBC considered that improved drainage would not bring sufficient benefit for the cost involved. At the time the FoEP disagreed with this conclusion but it was later pointed out in a report produced for the Management Committee by the FoEP Chair that the Park is actually providing a significant environmental benefit by holding back water that could otherwise increase the risk of flooding further down the Walbeck Brook catchment. Rather than attempting to increase the rate of drainage from the Park, NBC should seek to improve water retention by appropriate management of the Lake and ponds. Access to the waterlogged Park should be improved by the provision of four additional all-weather surfaced footpaths. This has been accepted in principle by NBC and three such pathways have now been costed. Currently, funding is not available for the construction of these paths and securing such funding should be a priority for the Management Committee and the FoEP.

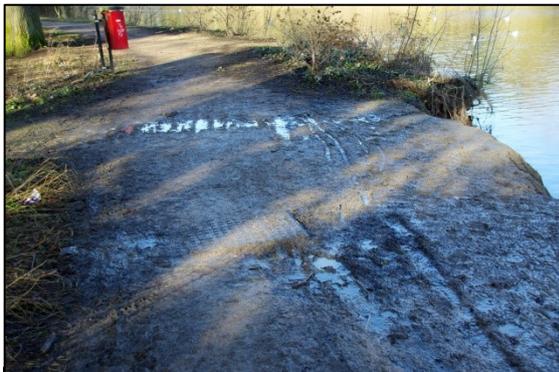
Mallard Walk is the only all-weather cross-park pathway. It was constructed in 2014 and is surfaced with self-binding gravel. Last year it was reported as being “in fair condition apart from where it passes close to the Lake.” The section by the Lake was not constructed to the same high standard as the rest of the path (because it was considered to be across high ground that was well drained) and is still in poor condition (Fig. 7). It is also of some concern that the bank of the lake is eroding towards the path (Fig. 8). The footpath is constructed across the top of a low earth embankment that holds back the lake water. If the embankment was ever breached water would flow across the Park towards the Eastfield Estate. It is therefore essential that the bank should be well maintained. Contractors’ vehicles often follow Mallard Walk and this is part of the reason for damage to the path. Consideration should be given to banning vehicles from crossing the embankment.

Fig. 7: Unacceptable condition of Mallard Walk as it passes by the Lake.

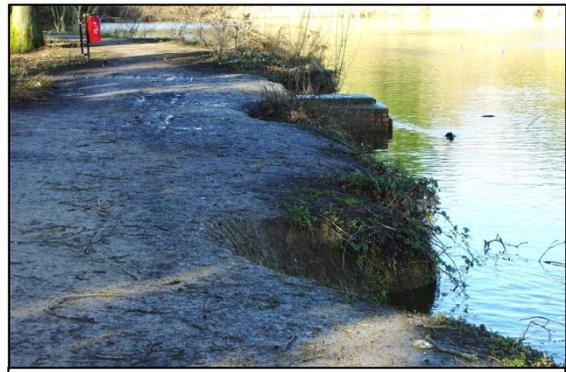
Fig. 8: Badly eroded Lake Embankment.

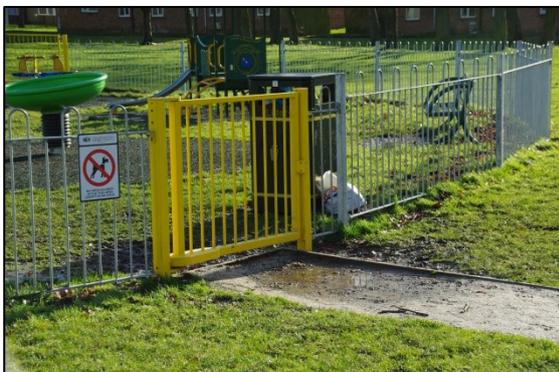
The southern part of Mallard Walk now has some deep potholes along it (Fig. 10). It is believed that these are the result of illegal motorcycles doing ‘wheelies’ along the path. Also, the spur from Mallard Walk to the new Junior Play Area is badly worn close to the gate to the play area (Fig. 9).

Fig. 9: Worn area of pathway at the gate to the Junior Play Area.

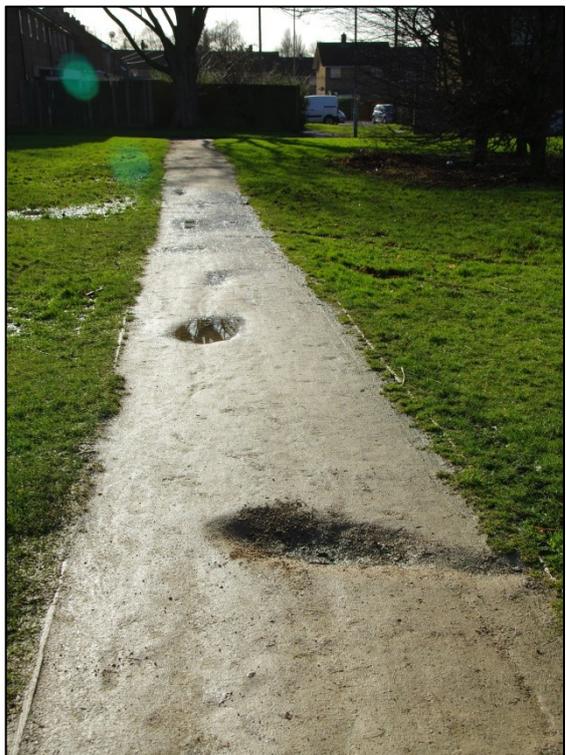
Fig. 10: Potholes at the southern end of Mallard Walk.

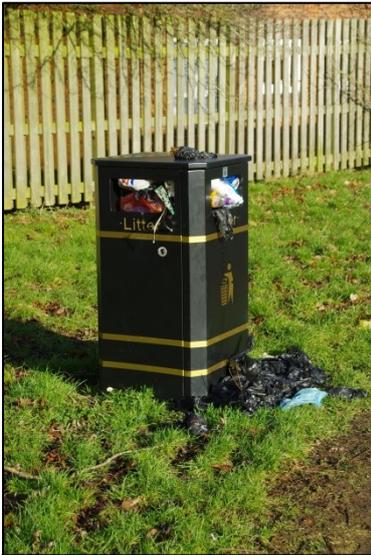
Fig. 12: New Waste Bin W10, overflowing with rubbish

At the time of the inspection, several waste bins had not been emptied for some considerable time and were overflowing with waste, especially bagged dog mess (Fig. 12). This unacceptable situation did indicate two positive aspects: first that the vast majority of dog walkers are picking up and bagging dog faeces, and secondly that they are now aware they can utilise ordinary waste bins to dispose of the bagged mess (but unfortunately sometimes choosing a clogged waste bin where there is an almost empty dog bin nearby.)

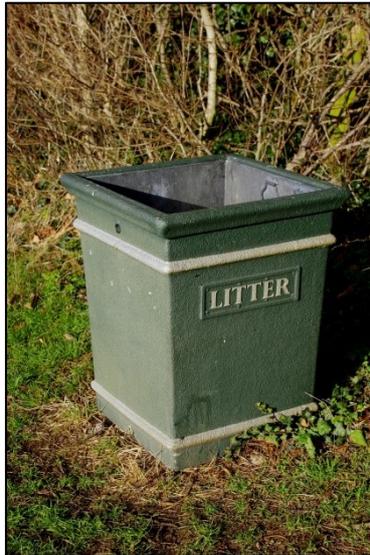
Fig. 13: Litter Bin L2, old but in good condition and empty.

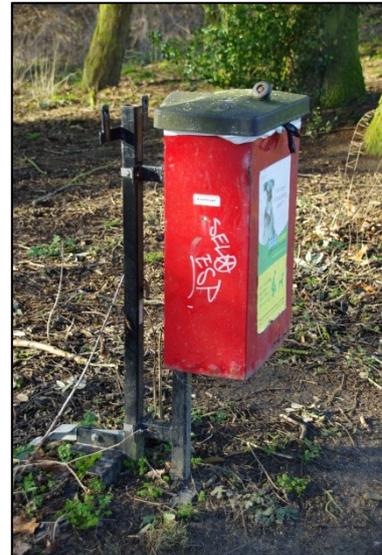
Fig. 14: Dog Bin D8, damaged but still functional.

Most of the dog bins are showing signs of their age but all were deemed to be ‘satisfactory’ or better². The foot pedal on Dog Bin D8, for example, no longer works, the lid is stiff to open and the bin itself is beginning to corrode and has graffiti scrawled on it (Fig. 14) but it is still functional and scored a ‘satisfactory’ rating (3G). This particular bin is located on the Lake embankment and last year there were two bins (D7 and D8) mounted on the same post in this position. Both were assessed as ‘unsatisfactory’ (2). D7 was later removed and D8 was replaced with a bin from elsewhere.

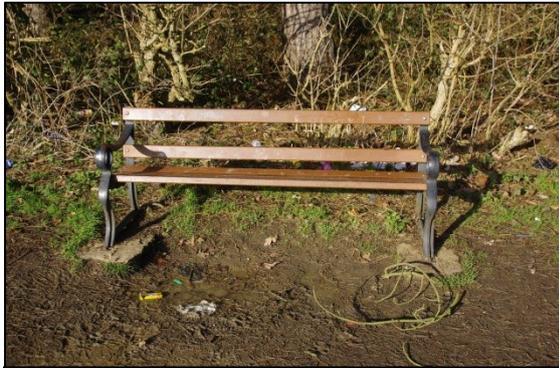
Fig. 15: Bench S2 – Only superficial damage but badly eroded ground in front.

However all of the benches (old and new) suffer from badly eroded ground in front of them, producing muddy or water-filled depressions (Fig. 15 to 18). This indicates just how much these benches are used and highlights the importance of remedial action. It is worth noting that Bench S4 (Fig. 17) is made of wood. While it is NBC policy not to install any more wooden benches, this does perhaps indicate that vandalism in the Park is not as great as sometimes perceived.

The depressions in front of existing benches need to be filled and, ideally, paving stones placed over areas most subject to wear. The exposed metal plates on the climbing pyramid need to be covered with protective matting and the cables tightened.

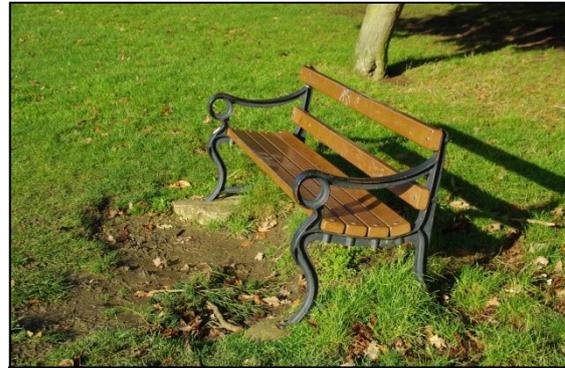
Fig. 16: Bench S5 – Mainly cosmetic damage but badly eroded ground in front.

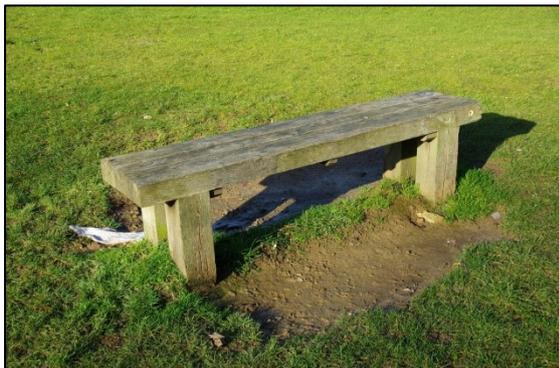
Fig. 17: Bench S4 – Wooden bench in good condition but eroded ground on both sides.

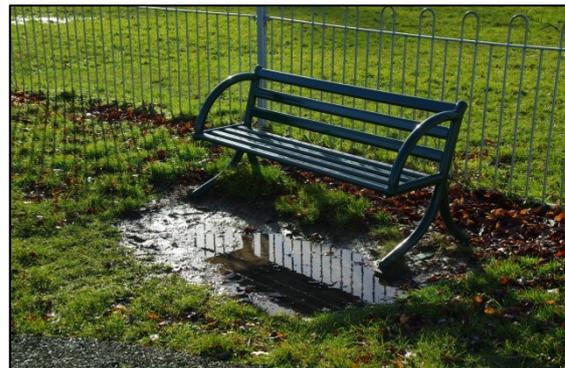
Fig. 18: Bench S6 in Junior Play Area – Excellent condition but large puddle in front.

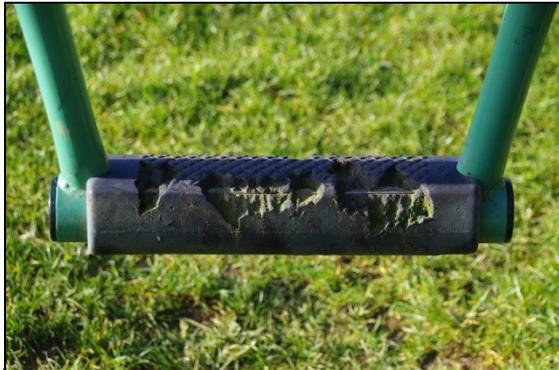
Fig. 19: Wear & tear on the Multi-pondo Rocker in the Senior Play Area – January, 2018.

Condition of equipment in the Senior Play Area has remained almost unchanged over the last two years. A picture of damage to the rubber covering on one of the foot-bars of the Multi-pondo Rocker taken in 2018 (Fig. 19) shows very little difference to a picture of the same bar taken in 2016 (Fig. 20). Similarly, a photograph taken in 2018 showing one of the ground fixings for the climbing pyramid (Fig. 21) reveals little difference compared to a picture of the same fixing taken in 2016 (Fig. 22). Grass has covered some of the exposed matting under the cables but the metal plate over the fixing is still exposed. This metal plate has been regarded as an unacceptable hazard by a number of Park users but apparently has not been considered unacceptable by those responsible for risk assessing the apparatus. The cables on the climbing pyramid are also somewhat damaged but this was not considered dangerous at the time of the inspection. However, they are rather loose and should be tightened before the summer season begins.

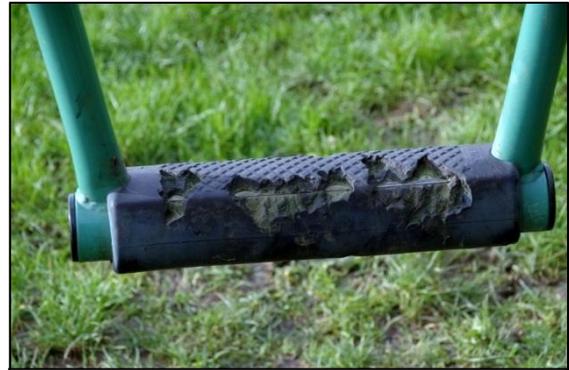
Fig. 20: Wear & tear on the Multi-pondo Rocker in the Senior Play Area – January, 2016.

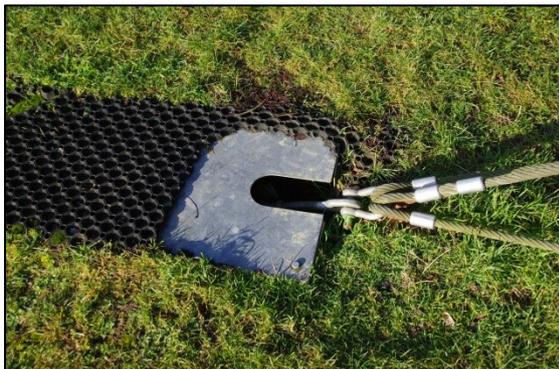
Fig. 21: Exposed ground fixings for the climbing pyramid – January, 2018.

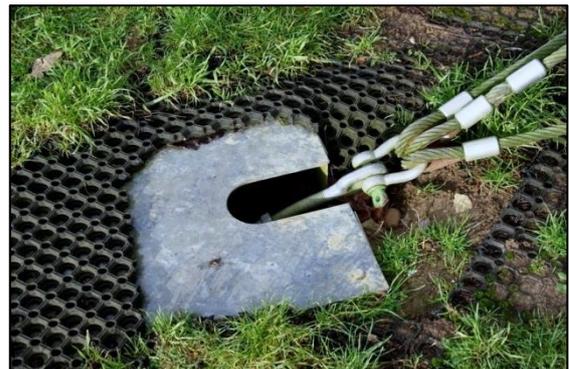
Fig. 22: Exposed ground fixings for the climbing pyramid – January, 2016.

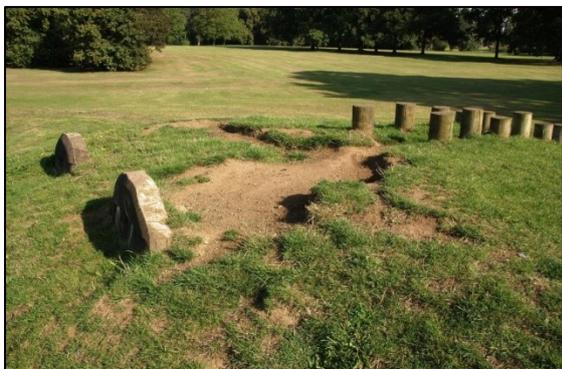
The top of the play mound (the monster’s ‘head’) was in very poor condition two years ago (Fig. 23) but was restored by volunteers in autumn, 2016. The repaired area has sunken slightly but now has a good growth of grass on it (Fig. 24).

Fig. 23: The top of the ‘Eastfield Monster’ was in need of repair – September, 2016.

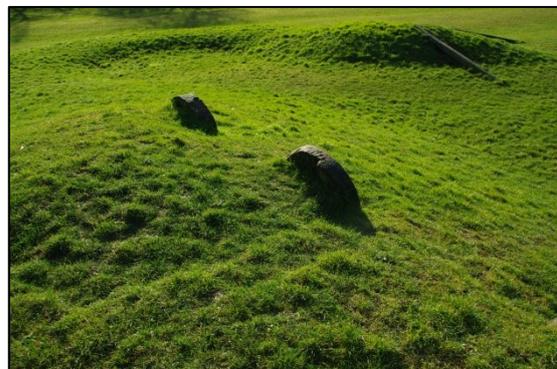
Fig. 24: The top of the ‘Eastfield Monster’ in January, 2018.

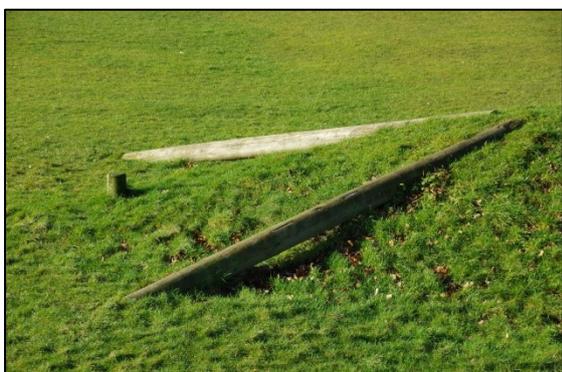
Only one of the posts, originally on the ‘claws’ of the monster, is still present; the others were removed, either by vandals or by officials because they were badly decayed (Fig. 25). However, the holes left by the posts were filled in by the Park Ranger and volunteers and are now covered with grass. In contrast, only one of the posts on the ‘spine’ of the monster is missing and the remaining posts are all in good condition (Fig. 27). The wooden structures added to the ‘tail’ of the monster in 2015 are still in good condition (Fig. 26).

Fig. 25: One of the Monster’s claws with only one post left – January, 2018.

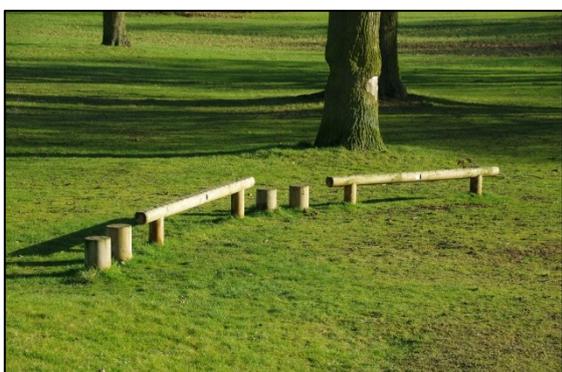
Fig. 26: Wooden structures added to the Monster’s tail in 2015 – January, 2018.

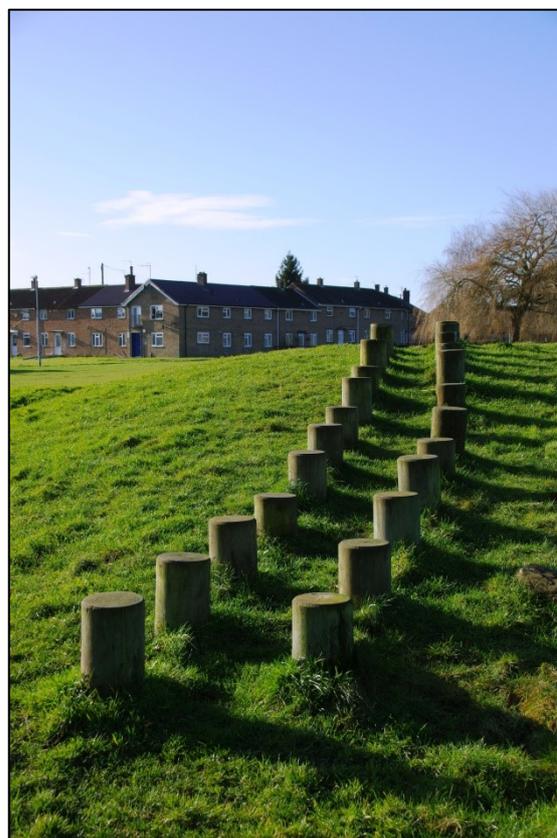
Fig. 27: The spine of the Monster with most posts still present – January, 2018.

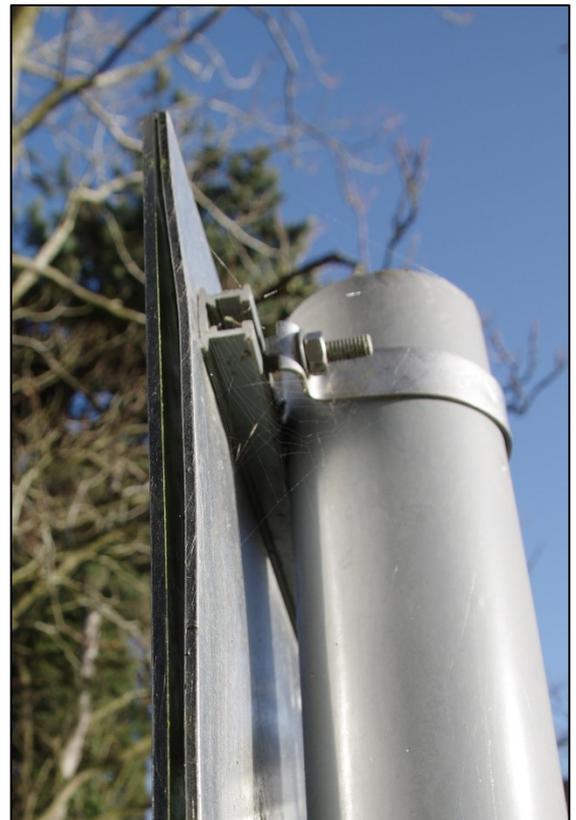
Fig. 28: Welcome Board at the Skiddaw Walk Entrance to the Park. As with most of the Welcome Boards, the two layers are coming apart.
