EASTFIELD PARK NORTHAMPTON

STATE OF THE PARK

January, 2017

STATE OF THE PARK - January, 2017

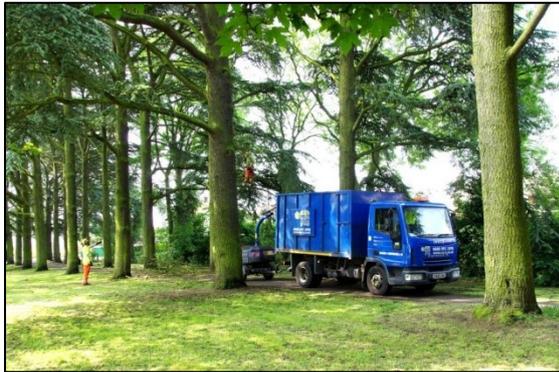
Many dead or hazardous branches were removed, some trees were pollarded and diseased and/or dangerous trees were felled (Fig. 1). The tree surgeons worked in an environmentally sensitive way and did not disturb trees with nesting birds in them.

Figure 1: Tree surgeons from the Acorn Environmental Management Group removing dangerous branches in Apple Tree Walk.

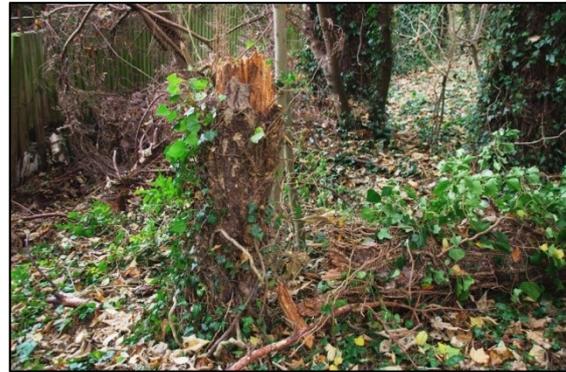
The tree work included areas within the spinneys but these still contain several trees with rotten trunks that are potentially dangerous (Fig. 2). It is not advisable to walk through the spinneys in windy weather.

Figure 2: Rotten tree in the Pond Area of Eastfield Park. The trunk snapped during a storm in December, 2016.

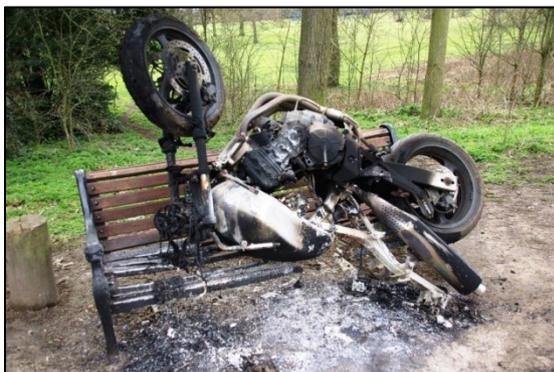
Last March, the seat that was near the lake outfall (S2) had a stolen motorbike placed on it and both seat and bike were set fire to (Fig. 9). The litter bin that had been by the seat (L4) and was in the Lake last year has been removed and is now in store. The other seat near the lake (S1) (which had been described in 2016 as ‘almost pristine’) has also been damaged by fire but, since it is an all-metal seat, the damage is minimal. The missing dog bin (D14) was missing because it had been damaged by vandals and removed.

Figure 9: Burnt-out motorbike on seat by Lake - March, 2016.

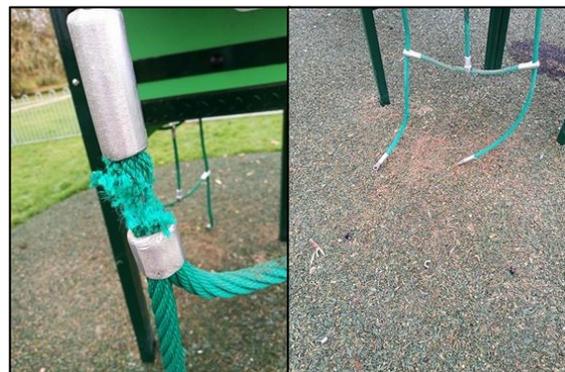
The same tower suffered further vandalism in November. First, insulation material from nearby building work was attached to the ‘rope’ ladder on the tower and an attempt made to burn it. The material, however, was fire resistant and only melted causing very little damage. An attempt was then made to cut through the ‘rope’. This was unsuccessful because the ‘rope’ has a steel core. Finally the attachments of the ladder to the ground were cut through (Fig. 10). This required considerable effort and was unlikely to have been carried out by a child. The damage was rapidly repaired and has not been repeated.

Figure 10: Damage done to Mordred Castle in the new Junior Play Area – November, 2016

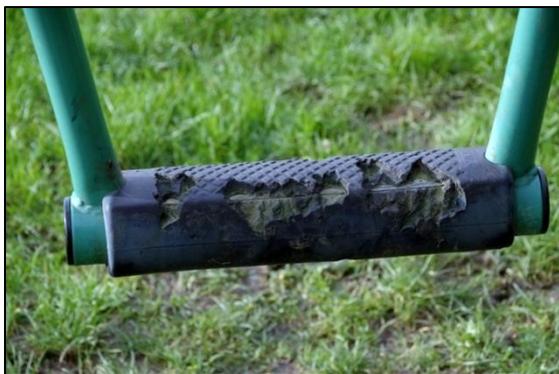
Figure 11: Wear & tear on the Multi-pondo Rocker in the Senior Play Area – January, 2016.

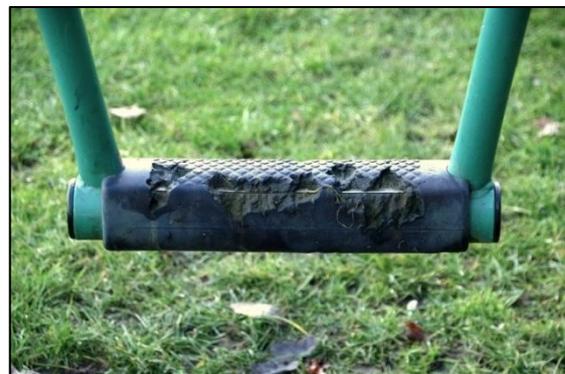
The condition of equipment in the Senior Play Area near the Lakeview Spinney is much the same as last year (Figs 11 to 14). The condition of the Climbing Pyramid was deemed satisfactory in 2016 but a note was made about the hazardous condition of the exposed metal plates where the pyramid is anchored to the ground. This year, the condition has been recorded as unsatisfactory for the same reason. The mini trail through the Lakeview Spinney is in a satisfactory condition but could be better maintained.

Figure 12: Wear & tear on the Multi-pondo Rocker in the Senior Play Area – January, 2017.

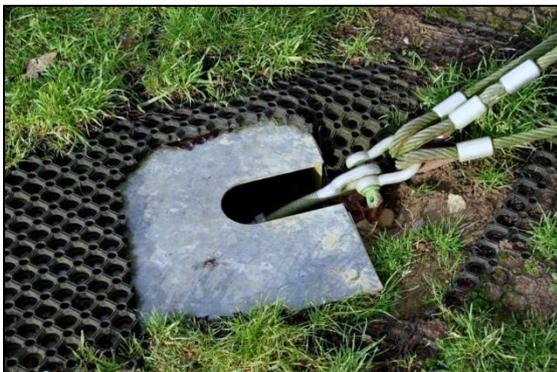
Figure 13: Exposed ground fixings for the climbing pyramid – January, 2016.

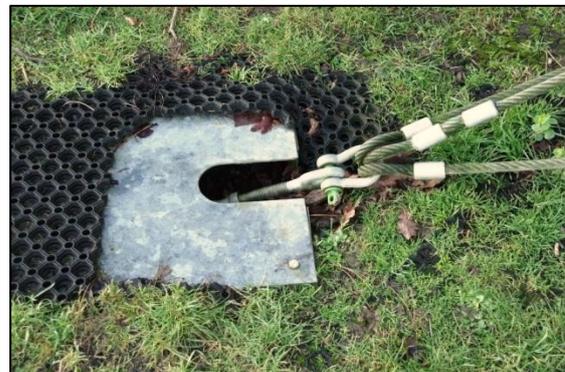
Figure 14: Exposed ground fixings for the climbing pyramid – January, 2017.

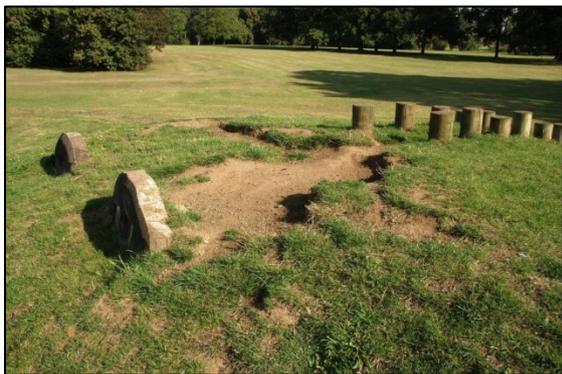
The ‘Eastfield Monster’ play mound is satisfactory although more of the logs have been removed, some by vandals but mostly because they were seriously decayed. The holes left by removed posts have all been filled and the top of the mound was restored (soil added and then seeded) by volunteers from Lloyds Bank (Figs. 15 & 16).

Figure 15: Top of the 'Eastfield Monster' in need of repair – September, 2016.

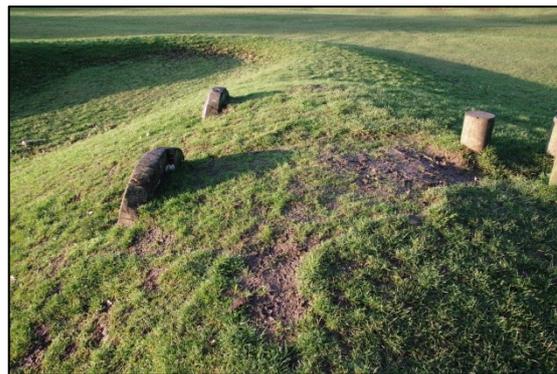
Figure 16: Top of 'Eastfield Monster' after repair and reseeded – January, 2017.

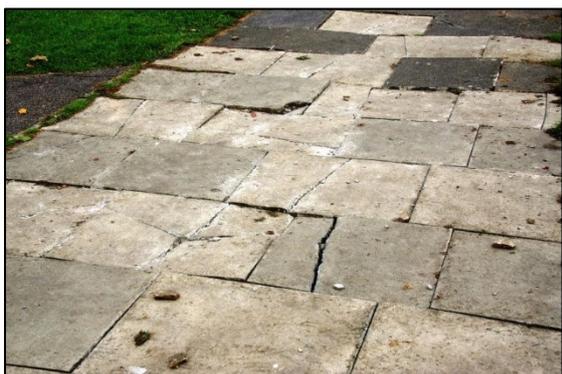
During 2016, Greenside suffered serious damage from contractors' vehicles using the footpath as a road. The most serious damage has been repaired but parts of the path remain unsatisfactory. Parts of Apple Tree Walk are also becoming unsatisfactory. Mallard Walk is in fair condition apart from where it passes close to the Lake. Contractors' vehicles often follow Mallard Walk (particularly the northern end) and this is beginning to result in damage to the path and the area adjacent to it.

Figure 17: Damage caused to Greenside by Contractor's vehicles – October, 2016.

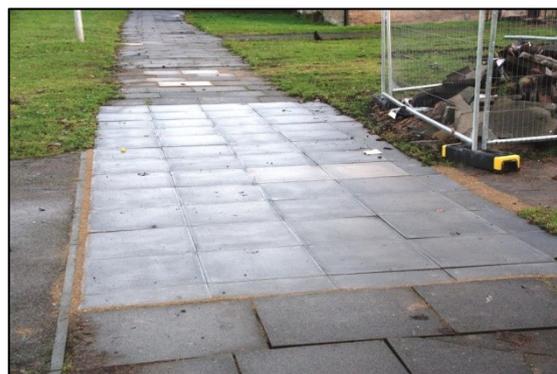
Figure 18: The same area of Greenside following repairs - January, 2017.
