EASTFIELD PARK NORTHAMPTON

STATE OF THE PARK

January, 2017

STATE OF THE PARK - January, 2017

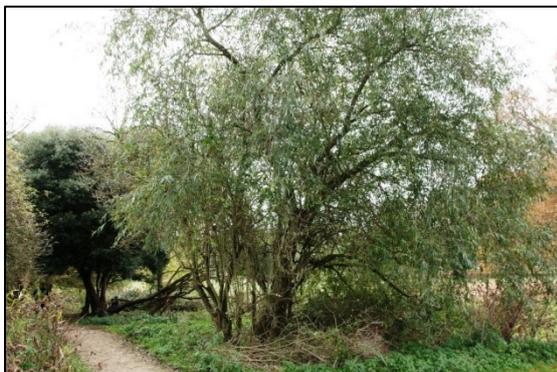
A considerable amount of work has been done on the slope leading up to Eastfield Park Lake (e.g. Figs 3 & 4). The majority of ‘weed trees’ and bushes have been cut down and the stumps are being poisoned with salt to prevent regrowth. Brambles will soon be removed and the area will be sprayed in spring to reduce weed growth. It is hoped to plant this area with clumps of dwarf daffodils, native bluebells and primroses during the autumn of 2017.

Figure 3: The area at the northern end of the slope leading up to Eastfield Park Lake before work started removing weed trees.

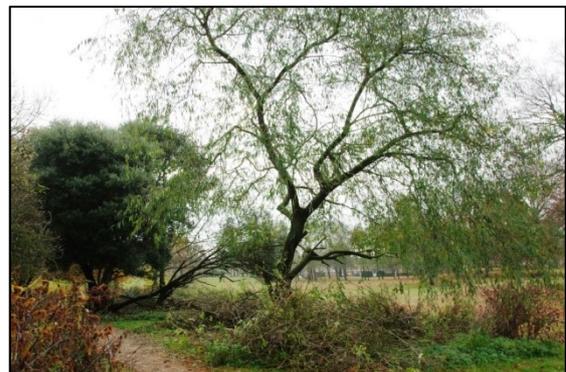
Figure 4: The same area as in Figure 3 with most of the weed trees removed. Much of the undergrowth will be removed in 2017.

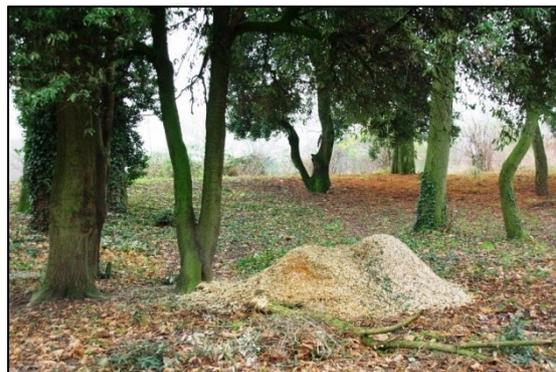
Many of the tree trunks and branches cut down in this area have been chipped with the help of NBC Neighbourhood Wardens (Fig 5). Piles of chippings remain (Fig 6) and we intend to use these for improving the muddy parts of footpaths in the spinneys.

Figure 6: Pile of shavings on the slope leading up to Eastfield Park Lake (now with weed trees removed).

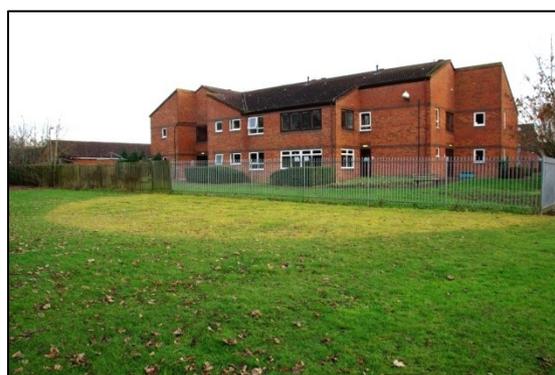
A semi-circular area in front of the wildflower border was sprayed with a garden herbicide in the autumn and most of the grass in the area is now dead (Fig 7). It will be sprayed again in early spring and, after the remaining grass and weeds have died, raked over and sowed with a mix of wildflower and meadow grasses including yellow rattle. Additionally, some wildflowers may be planted as plugs. The intention is to create an artificial meadow habitat that can be viewed from Eleonore House. Half of the Crescent Rock Garden was also replanted and weeded in 2016. Crocus and daffodils are already beginning to show through and snowdrops are beginning to bloom.

Figure 7: Area to north of Eleonore House sprayed with weed killer in preparation for creating an artificial meadow habitat.

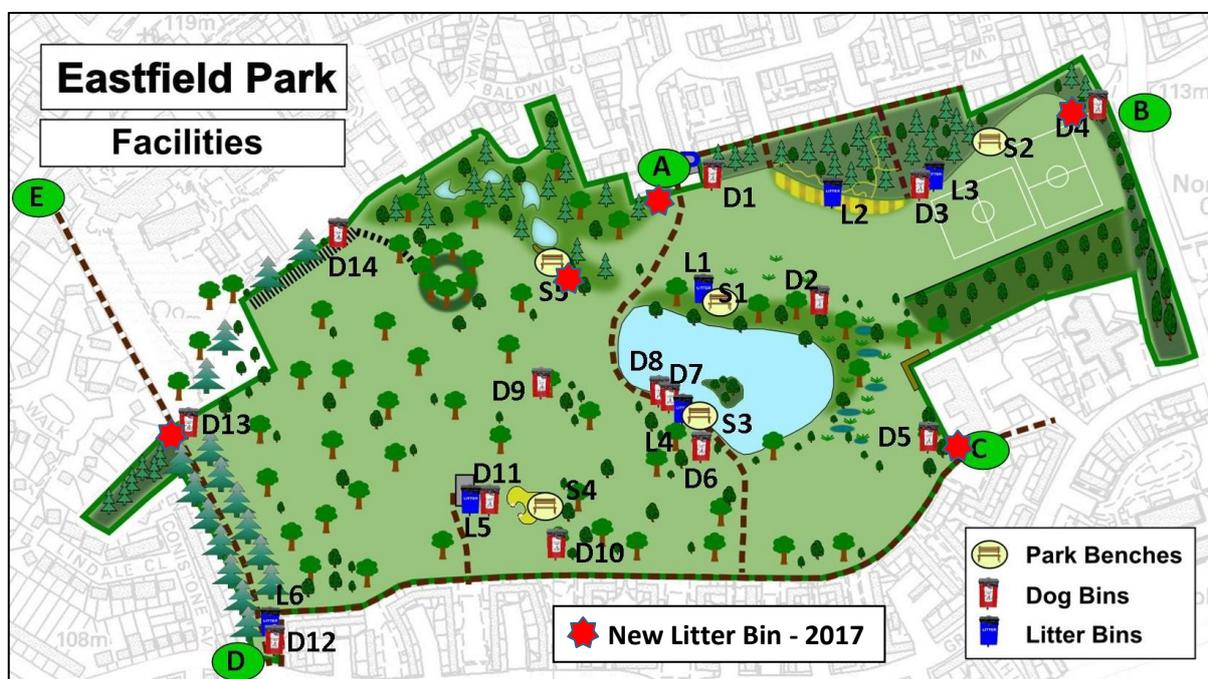
Vic Smith and Dean Byrne assessed the state of equipment and facilities in the Park (Fig 8) employing the same six point scale used the previous year. The limits of each category are rather arbitrary and assessments were often recorded as falling somewhere in a range between codes, e.g. '3/4'. The results of the assessments for last year and this year are compared in Table 2 where unsatisfactory situations are shown in red, brown or orange.

In January 2017, five new litter bins were installed in Eastfield Park in the locations indicated by red stars in Figure 8. These bins were not included in the assessment but, being new, their condition may be assumed to be 'pristine'.

Figure 8: Equipment and facilities in Eastfield Park. A: Skiddaw Walk entrance, B: Booth Lane entrance, C: Eleonore House entrance, D: Greenfield Avenue entrance, E: Kettering Road entrance, D1 to D14: Dog bins, L1 to L6: Litter bins, S1 to S5: Park benches. The positions of the five new litter bins are shown by red stars.
